MEMORANDUM

SUBJECT: City of Middleton C29 Airport Master Plan Chapter 3: Facility Requirements

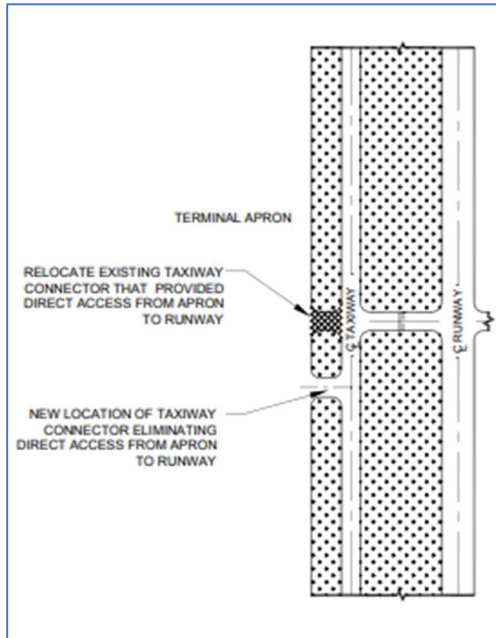
Figure 1: Pavement Life Cycle

The existing configuration of Taxiway A2 allows direct access between the primary runway and the Terminal/FBO apron. The FAA considers this configuration to be a potential safety hazard and typically support efforts by the airport sponsor to remedy this situation. According to FAA Advisory Circular (AC) 150/5300-13A, airports should not “design taxiways to lead directly from an apron to a runway without requiring a turn. Such configurations can lead to confusion when a pilot typically expects to encounter a parallel taxiway but instead accidentally enters a runway.” (See Figure 1) This should be a priority funding item to enhance safety at C29.

Source: FAA AC 150/5300-13A - Figure 4-3 Proper Taxiway Design

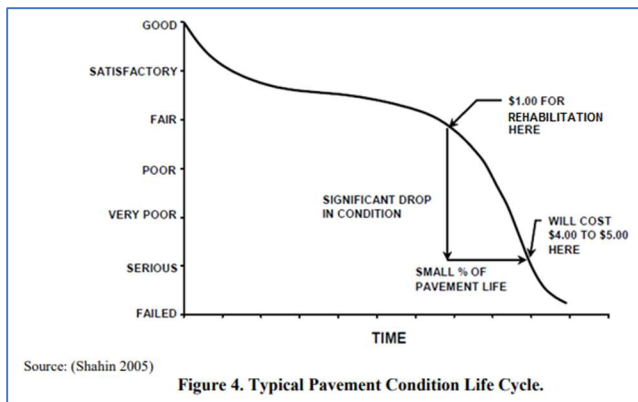
Figure 2: Pavement Life Cycle

Much of the pavement at C29 is reaching its anticipated useful life, and will likely require the commencement of rehabilitation efforts within the next 5-years. Based on Pavement Condition Index (PCI) numbers shown in Table 3-17 of the C29 Airport Master Plan, within the next 5-years, a significant number

of pavement areas will deteriorate to a PCI of 60, often considered the threshold for necessary pavement rehabilitation/construction. For various reasons, allowing pavement to deteriorate below this level can cause an accelerated drop in pavement conditions, greatly increasing rehabilitation/reconstruction cost. Figure 2 shows the accelerated nature of pavement conditions and rehabilitation costs once the PCI reaches the fair/poor condition. Pavement conditions as they relate to PCI values are shown below in Table 1.
